Manhole Inspection Summary

Manhole # S03WW1001MH

Insp Date: **10/12/06 12:15 PM**

Location Address: **5906 PARK HEIGHTS AVE**

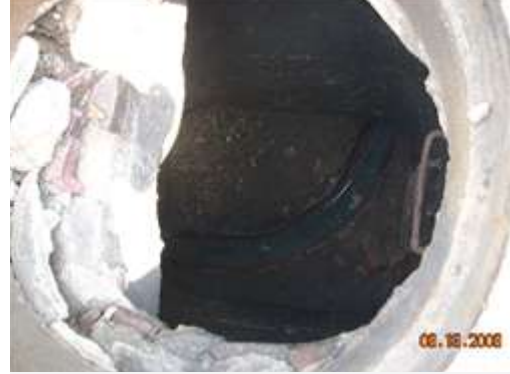
Top View

Corroded steps. Evidence of surcharge - Bench debris. Channel debris.

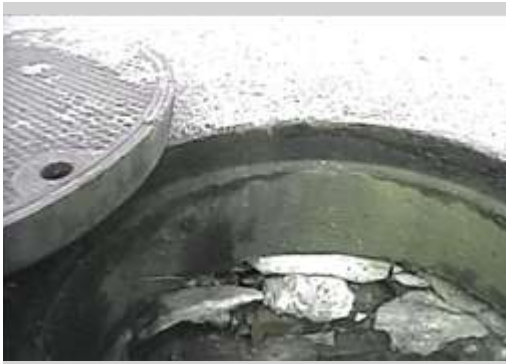
Defect

Frame leaks. Adjustment deterioration, loose brick and infiltration.

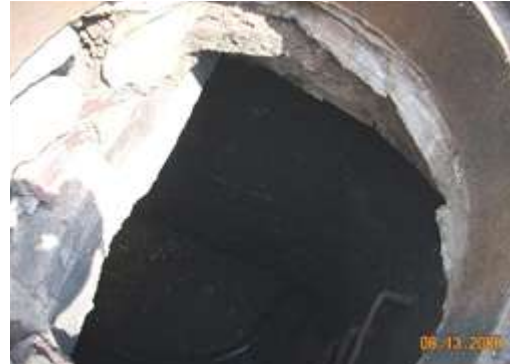
Defect

Frame leaks. Adjustment deterioration, loose brick and infiltration. Corbel and Barrel infiltration - other side.

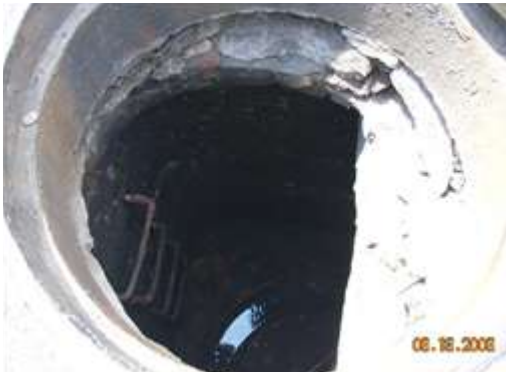
Defect

Frame leaks. Adjustment deterioration, loose brick and infiltration. Corbel and Barrel infiltration.

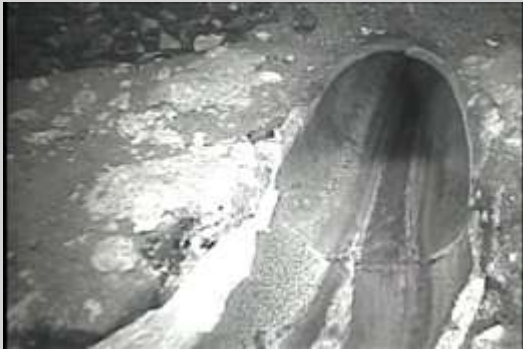
8 in. Circular Gravity Sewer Pipe Out @ 12 O'Clock

Infiltration: **Evidence** Pipe Seal Cond: **Broken**

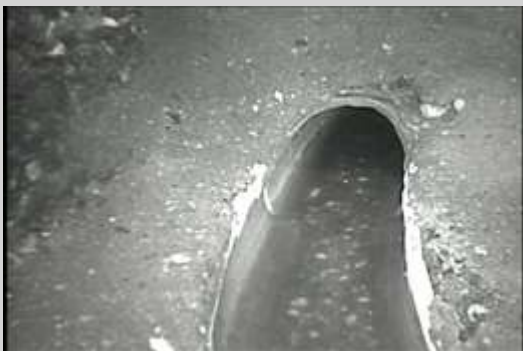
8 in. Circular Gravity Sewer Pipe In @ 9 O'Clock

Channel debris.

Deposits: ☐ None ☒ **Mud** ☐ Sludge ☒ **Debris** ☐ Grease

Silt Depth: **0.5** (in.) Deposits Extent: **Light**
